Inspection Report

November 19, 2009

231 Sample St.
Yanceyville NC

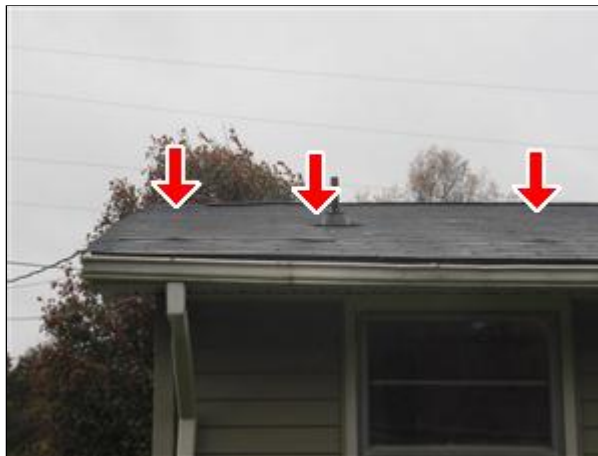
1.0 Picture 1

**1.0** The roof covering is bowing upwards in areas at the "entire roof". This could cause deterioration. A qualified person should repair or replace as needed.

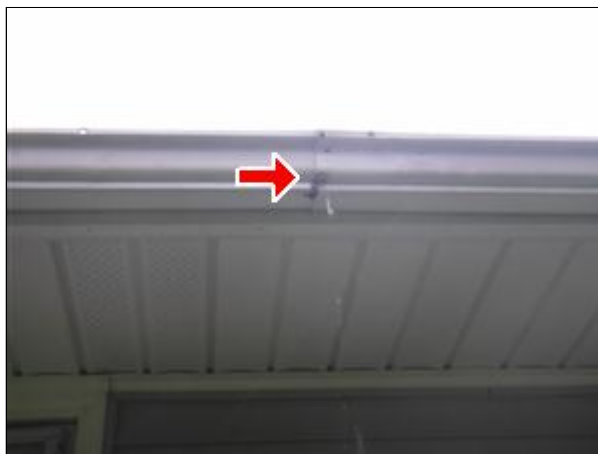
1.3 Picture 1

**1.3** The gutter leaks at seam (s) at the rear of the home . Loose or leaking gutters can cause deterioration of fascia, soffit or roof edge. It can also cause gutters to pull loose and lead to possible water intrusion. A qualified person should repair or replace as needed.

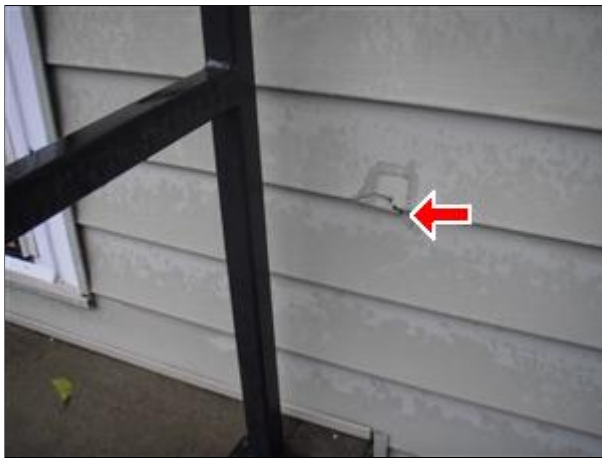
2.0 Picture 1

**2.0** The Vinyl siding at the front of home and the right side (facing front) is damaged. Further deterioration can occur if not corrected. A qualified person should repair or replace as needed.

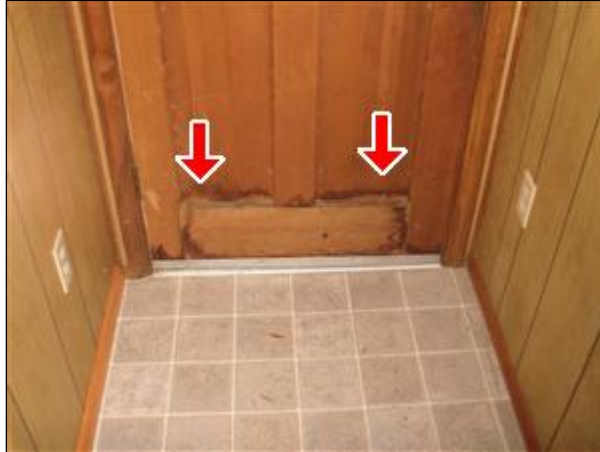
2.1 Picture 1

2.1 The side entry door has moisture stains indicating a current or prior leak . Further deterioration may occur if not repaired. A qualified person should repair or replace as needed.

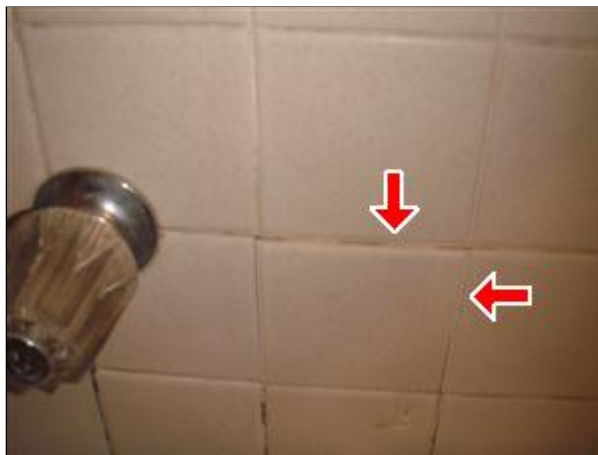
3.1 Picture 1

**3.1** (1) The tile surround at the bathtub wall is deteriorated and needs repair or replacement. The wall board and framing may need repair (not visible). I recommend repair or replace using a qualified contractor.

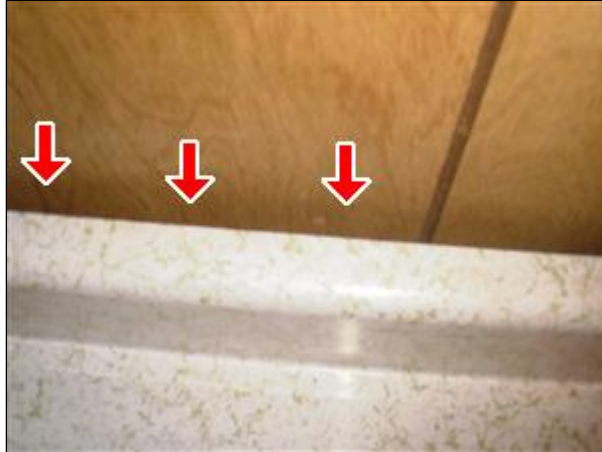
3.4 Picture 1

3.4 The kitchen counter and cabinetry is pulling away from the wall. Recommend a qualified professional repair or replace.

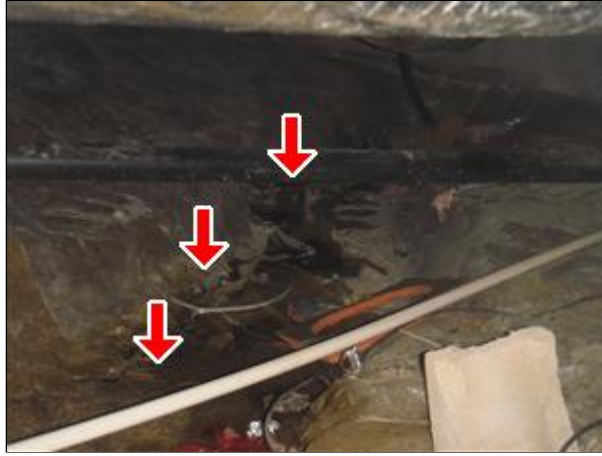
4.0 Picture 1

4.0 Visible signs of water intrusion in the crawlspace are present from standing water. Water intrusion if not corrected can lead to other problems including mold and cause excessive moisture to floor system that can lead to deterioration and increased repair cost.. I recommend further investigation or correction by a qualified licensed contractor or water infiltration specialist.

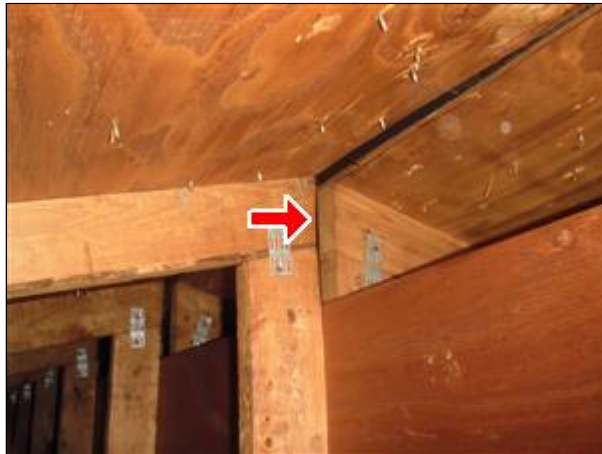
4.5 Picture 1

4.5 The 2x4 trusses are missing the crimp plate at the peak of the trusses. Repairs are needed to maintain the stability of the roof. Truss repairs should be approved by an engineer or qualified architect before performing the work involved.

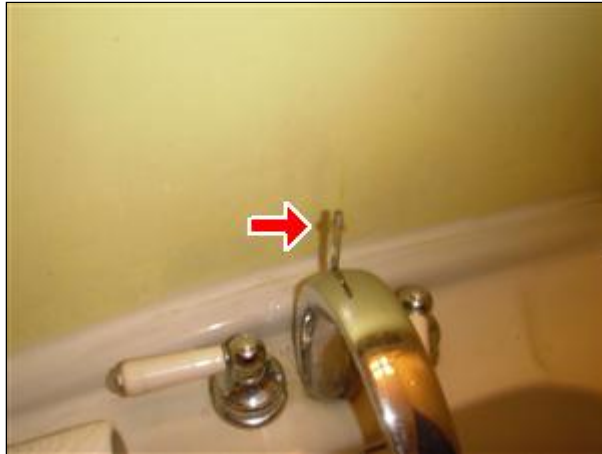
5.0 Picture 1

**5.0** The stop-valve linkage is damaged at the Hall Bath sink. Repairs are needed. A qualified licensed plumber should repair or correct as needed.

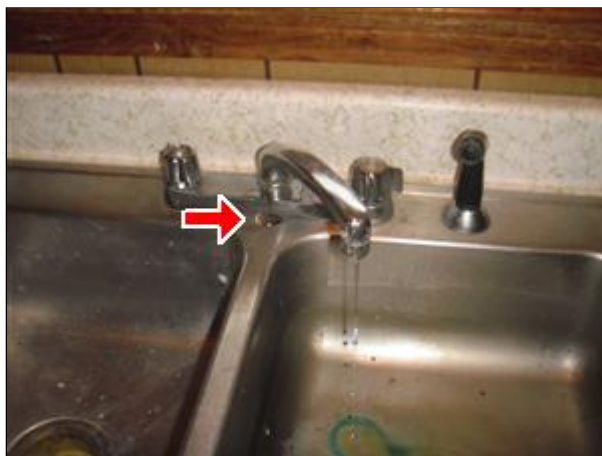
5.1 Picture 1

**(2)** The faucet leaks and drips at the kitchen sink. Repairs are needed. A qualified licensed plumber should repair or correct as needed.

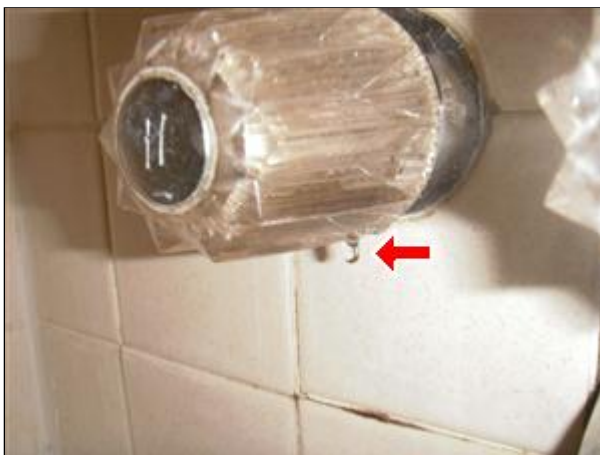
5.1 Picture 2

(3) The hot control leaks at the hall bathtub. Repairs are needed. A qualified licensed plumber should repair or correct as needed.

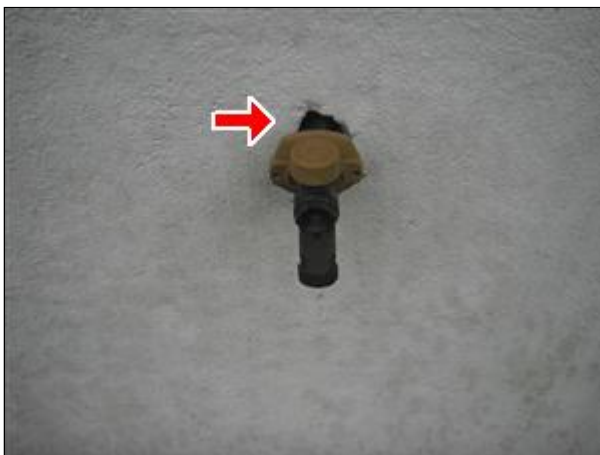
5.1 Picture 3

(4) The hose bib is missing knob(s) at the at the front of home. Repairs are needed. A qualified licensed plumber should repair or correct as needed.

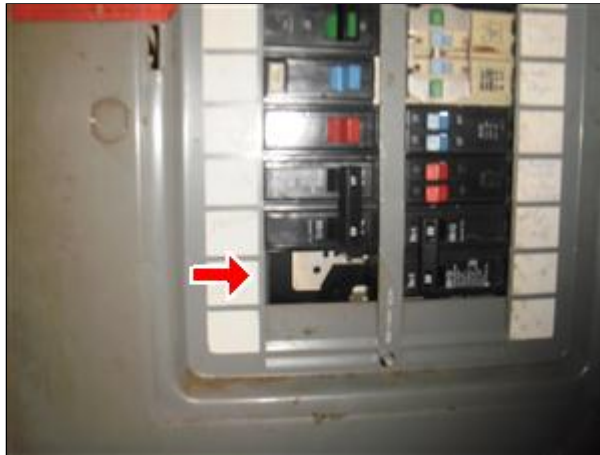
6.1 Picture 1

6.1 The main panel box is located at the kitchen. The panel circuits are not clearly labeled and is missing knockouts (DANGEROUS). Electrical issues are considered a hazard until repaired. A qualified licensed electrical contractor should correct as needed.

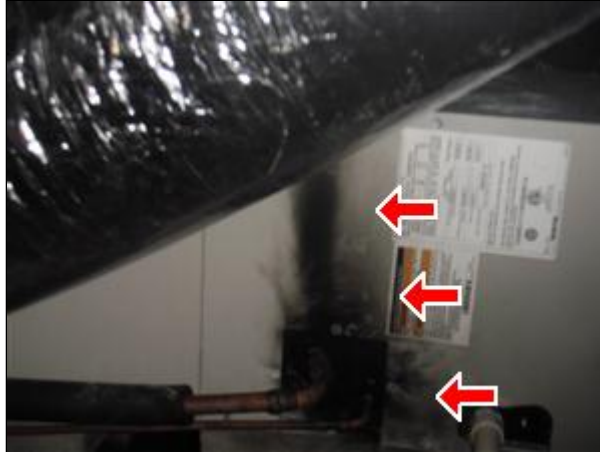
7.0 Picture 1

7.0 There is evidence of a fire at the HVAC system located in the crawlspace. I am unable to determine if the item was repaired. Recommend a mechanical contractor to evaluate and/ or make the needed repairs.

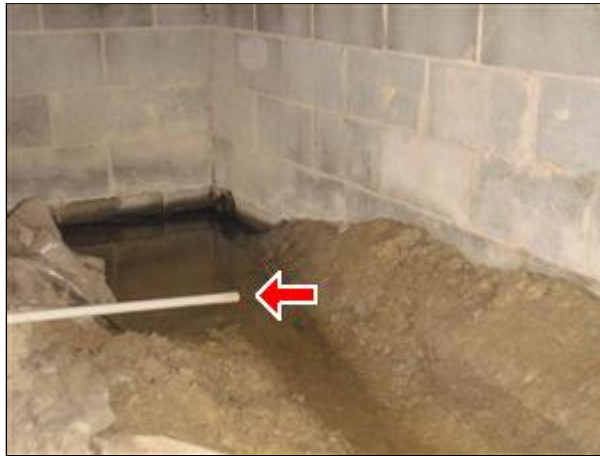
7.3 Picture 1

7.3 The condensation line needs an extension to carry water away from home. It is currently emptying into the crawlspace. This can cause numerous problems. A qualified person should repair or replace as needed.

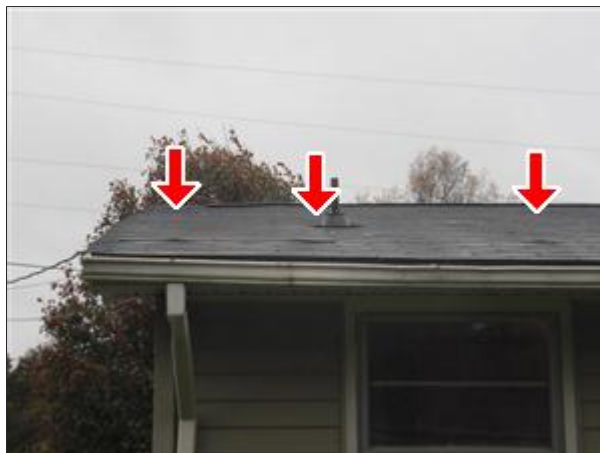
1.0 Picture 1

The roof covering is bowing upwards in areas at the "entire roof". This could cause deterioration. A qualified person should repair or replace as needed.

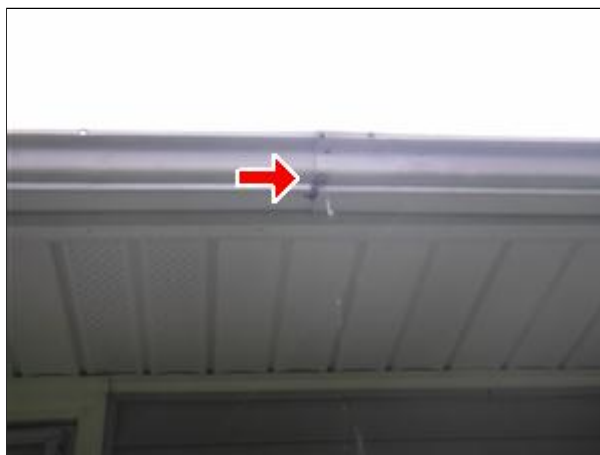
1.3 Picture 1

The gutter leaks at seam (s) at the rear of the home . Loose or leaking gutters can cause deterioration of fascia, soffit or roof edge. It can also cause gutters to pull loose and lead to possible water intrusion. A qualified person should repair or replace as needed.

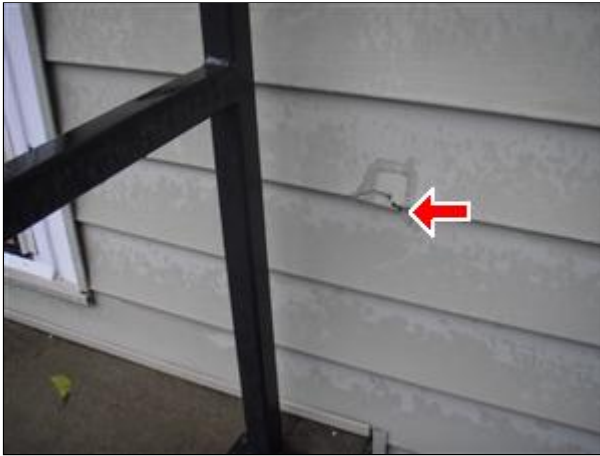
2.0 Picture 1

The Vinyl siding at the front of home and the right side (facing front) is damaged. Further deterioration can occur if not corrected. A qualified person should repair or replace as needed.

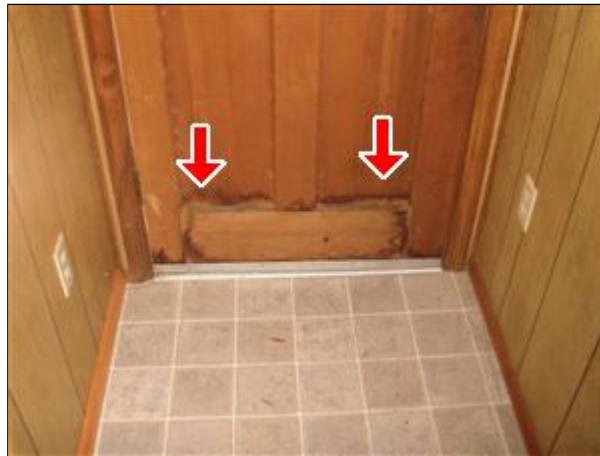
2.1 Picture 1

The side entry door has moisture stains indicating a current or prior leak. Further deterioration may occur if not repaired. A qualified person should repair or replace as needed.

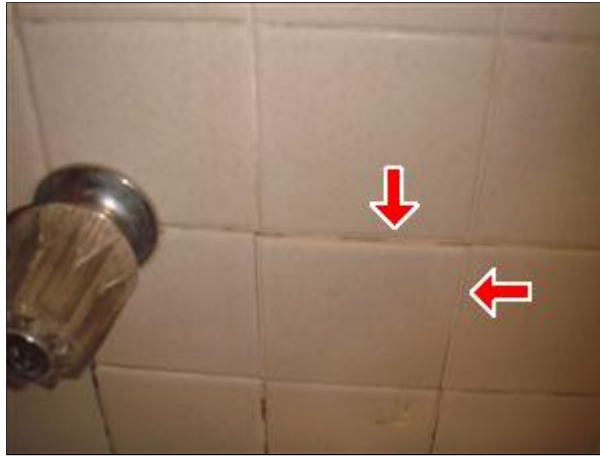
3.1 Picture 1

(1) The tile surround at the bathtub wall is deteriorated and needs repair or replacement. The wall board and framing may need repair (not visible). I recommend repair or replace using a qualified contractor.

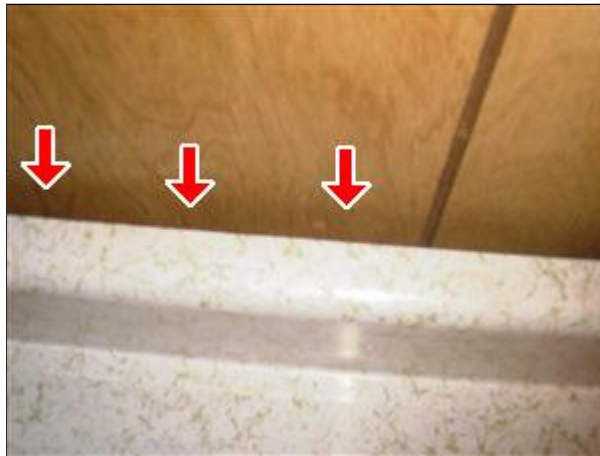
3.4 Picture 1

The kitchen counter and cabinetry is pulling away from the wall. Recommend a qualified professional repair or replace.

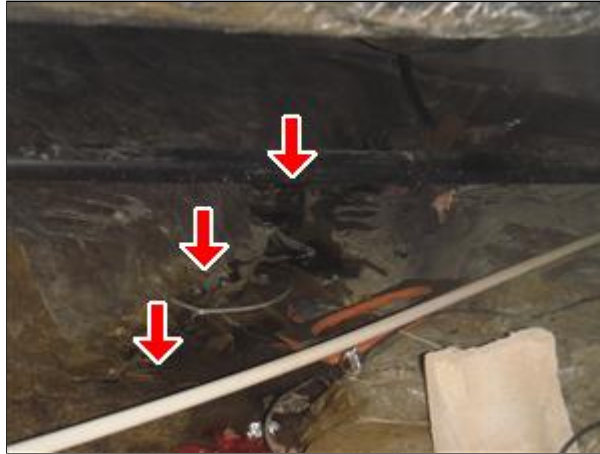
4.0 Picture 1

Visible signs of water intrusion in the crawlspace are present from standing water. Water intrusion if not corrected can lead to other problems including mold and cause excessive moisture to floor system that can lead to deterioration and increased repair cost.. I recommend further investigation or correction by a qualified licensed contractor or water infiltration specialist.

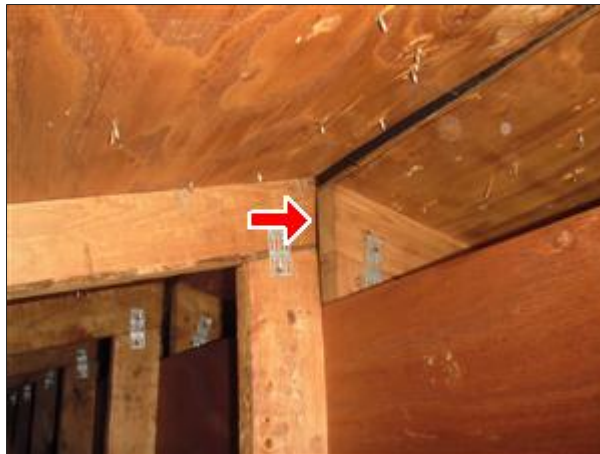
4.5 Picture 1

The 2x4 trusses are missing the crimp plate at the peak of the trusses. Repairs are needed to maintain the stability of the roof. Truss repairs should be approved by an engineer or qualified architect before performing the work involved.

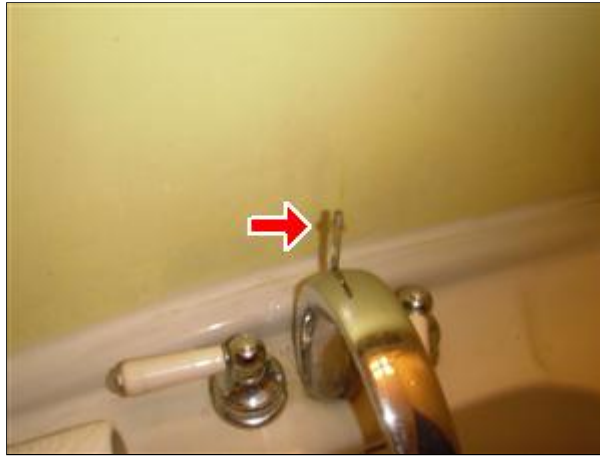
5.0 Picture 1

The stop-valve linkage is damaged at the Hall Bath sink. Repairs are needed. A qualified licensed plumber should repair or correct as needed.

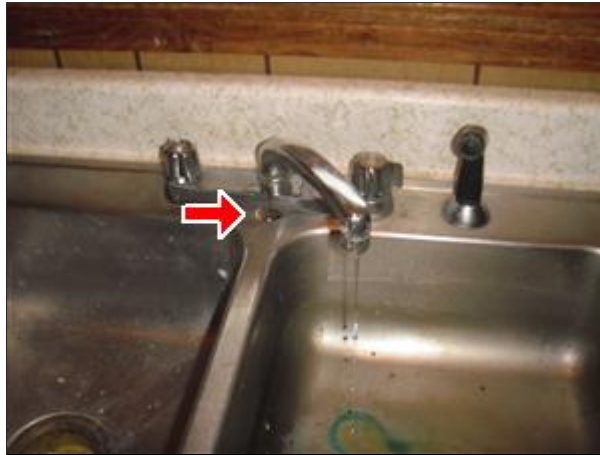
5.1 Picture 1

(2) The faucet leaks and drips at the kitchen sink. Repairs are needed. A qualified licensed plumber should repair or correct as needed.

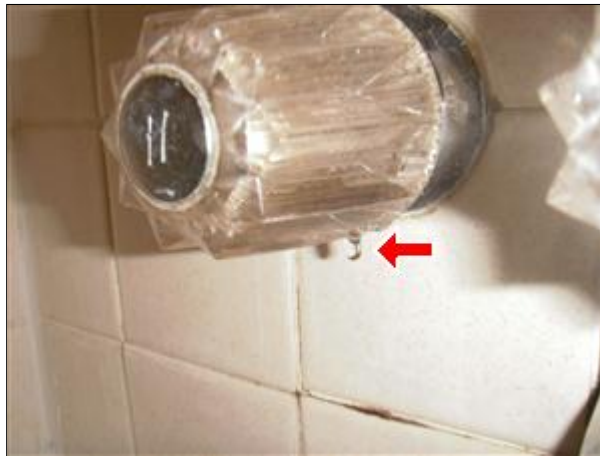
5.1 Picture 2

(3) The hot control leaks at the hall bathtub. Repairs are needed. A qualified licensed plumber should repair or correct as needed.

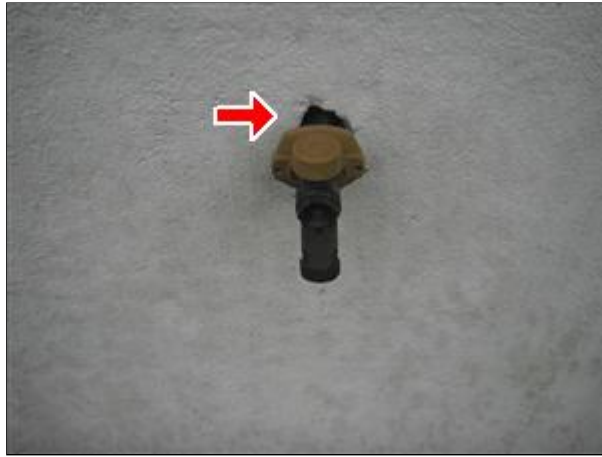
5.1 Picture 3

(4) The hose bib is missing knob(s) at the at the front of home. Repairs are needed. A qualified licensed plumber should repair or correct as needed.

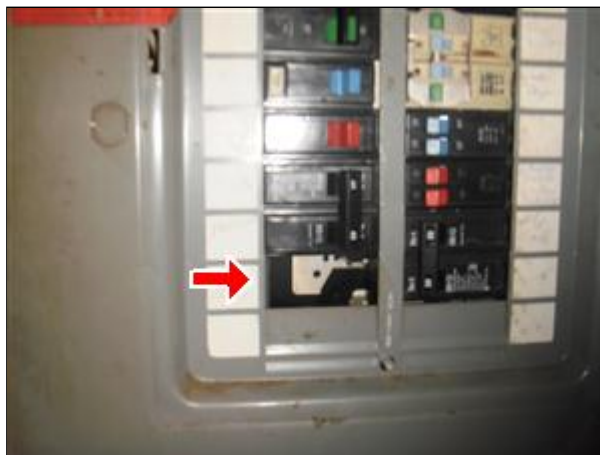
6.1 Picture 1

The main panel box is located at the kitchen. The panel circuits are not clearly labeled and is missing knockouts (DANGEROUS). Electrical issues are considered a hazard until repaired. A qualified licensed electrical contractor should correct as needed.

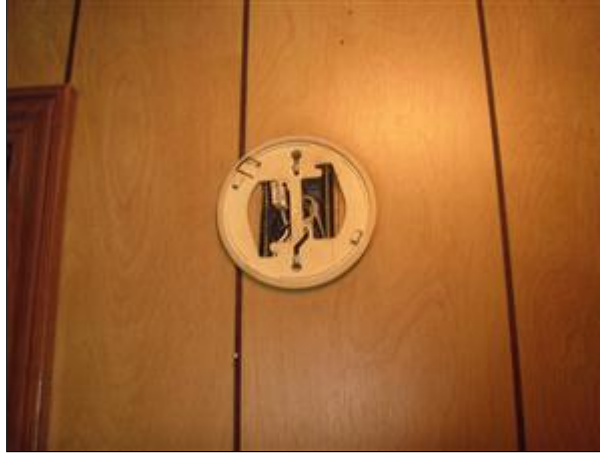
6.7 Picture 1

The smoke detector has been disconnected intentionally at the common hallway to bedrooms. Without a working smoke detector in your home you have no first alert to a possible fire. I recommend repair or replace as needed using a qualified person.

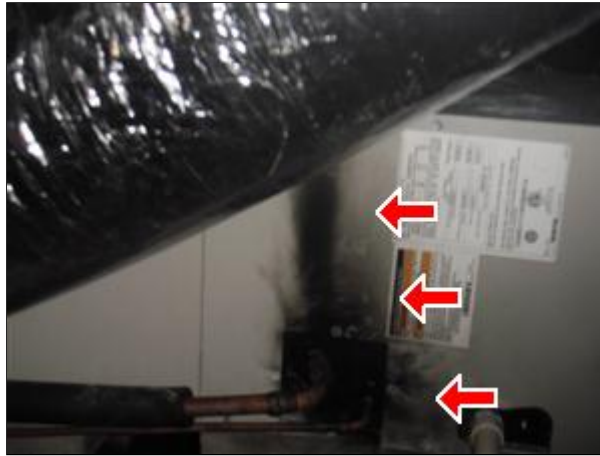
7.0 Picture 1

There is evidence of a fire at the HVAC system located in the crawlspace. I am unable to determine if the item was repaired. Recommend a mechanical contractor to evaluate and/ or make the needed repairs.

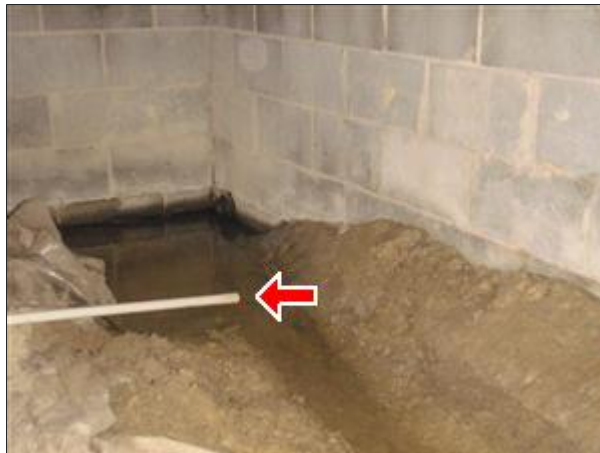
7.3 Picture 1

The condensation line needs an extension to carry water away from home. It is currently emptying into the crawlspace. This can cause numerous problems. A qualified person should repair or replace as needed.

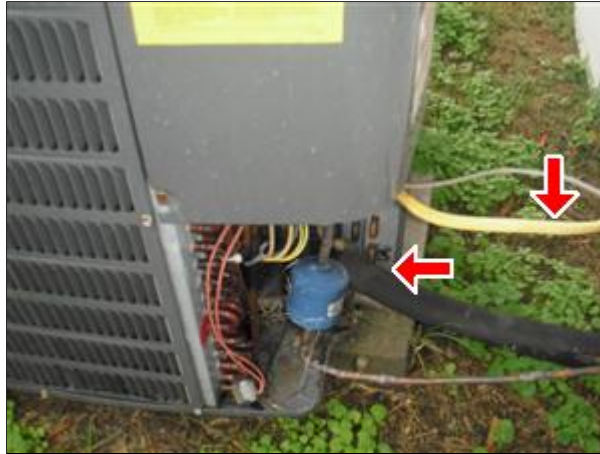
7.8 Picture 1

(1) The AC unit is missing a section of it's cover and the wiring for the unit is not properly secured in a conduit. This could pose a safety hazard and also lead to the deterioration of the unit. Recommend repair by a licensed mechanical contractor.
